Routine & Preventative Maintenance Conveyor Upper Wash Arm Falls Out

American Dish Service

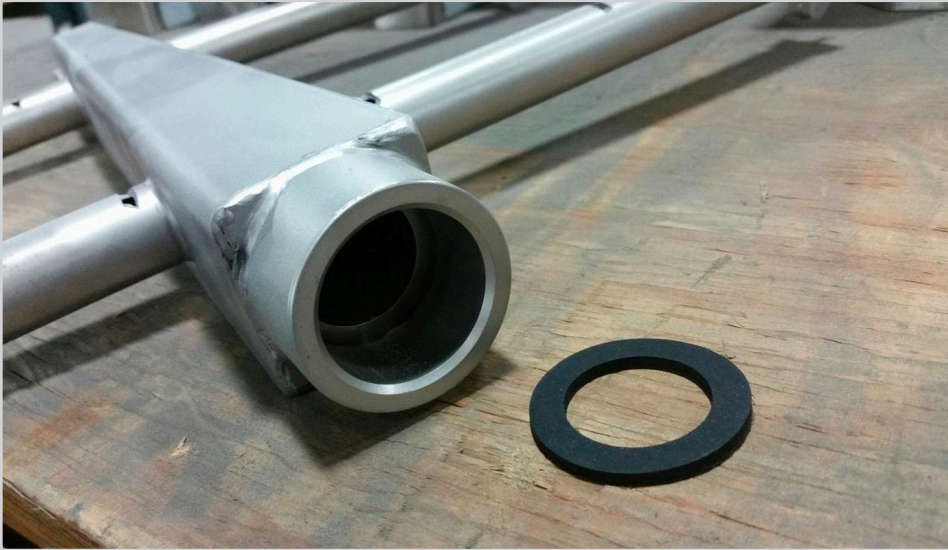
First, inspect the inlet side of the spray arm. There should be a flat rubber washer (289-6608) inserted into an inner channel of the spray arm. If this washer is missing, the arm will slide back on the manifold and fall out of the mount bracket (286-6177).

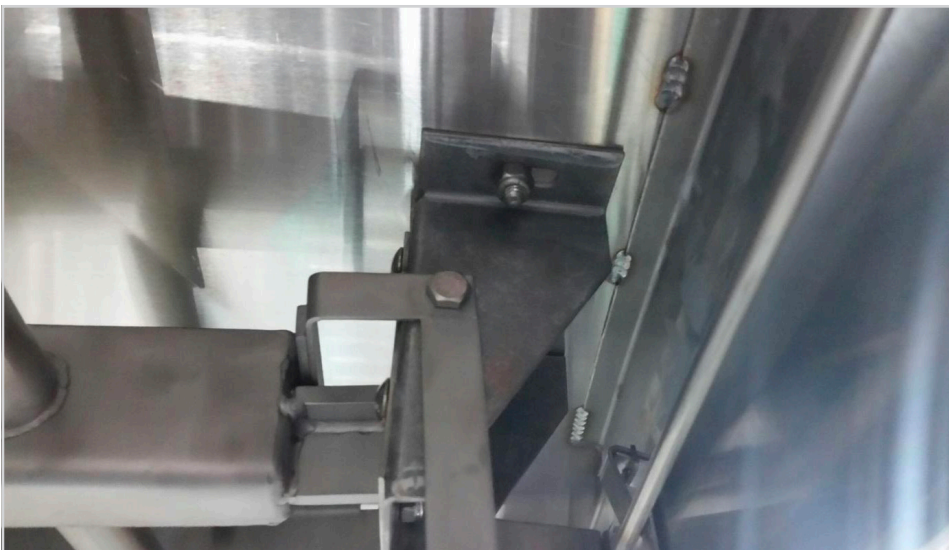
Second, if the wash arm has the washer properly installed inspect the upper wash arm mount bracket (286-6177). It is attached to the hood with weld studs. The correct position should be tensioned against the spray arm when the upper mount handle (285-6129) is pulled down against the spray arm end notch. If this is a loose handle in the down position, loosen the nuts holding the bracket and slide the bracket toward the spray arm until the handle comes down tight. This locks the spray arm to the manifold.
