## Routine & Preventative Maintenance Conveyor Upper Wash Arm Falls Out

**If the complaint is the upper wash arm on an ADS conveyor is continually falling out, there are two likely causes.**

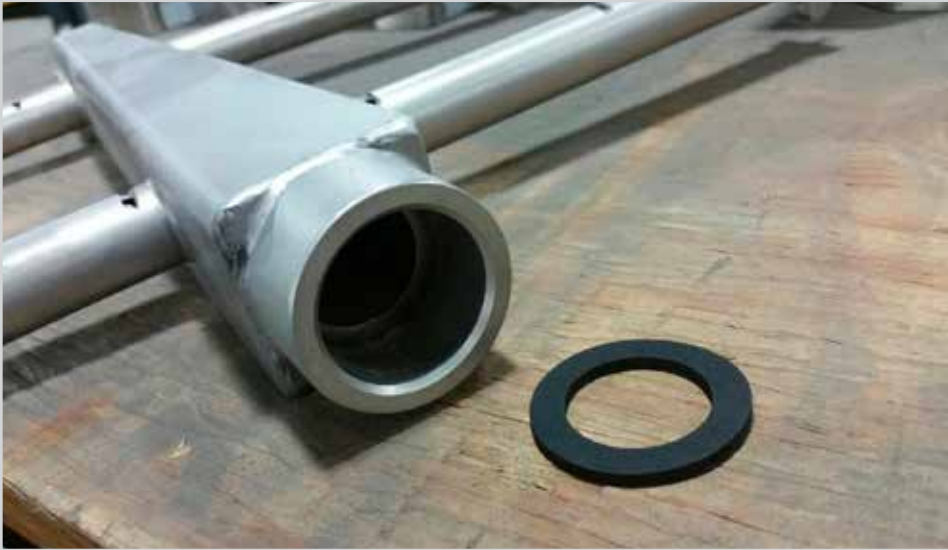
**First**, inspect the inlet side of the spray arm. There should be a flat rubber washer (289-6608) inserted into an inner channel of the spray arm. If this washer is missing, the arm will slide back on the manifold and fall out of the mount bracket (286-6177).

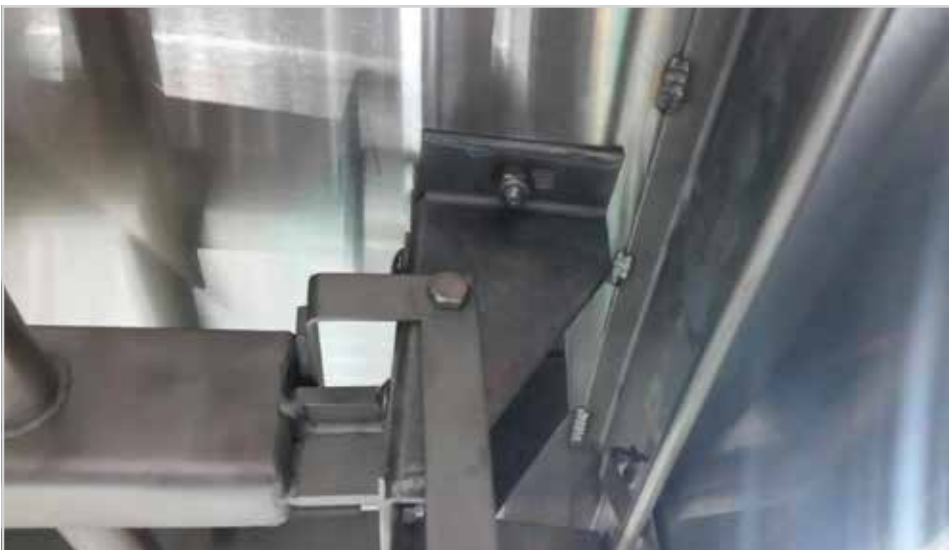
**Second**, if the wash arm has the washer properly installed inspect the upper wash arm mount bracket (286-6177). It is attached to the hood with weld studs. The correct position should be tensioned against the spray arm when the upper mount handle (285-6129) is pulled down against the spray arm end notch. If this is a loose handle in the down position, loosen the nuts holding the bracket and slide the bracket toward the spray arm until the handle comes down tight. This locks the spray arm to the manifold.
